AZTEC RUINS NATIONAL MONUMENT
ADMINISTRATIVE HISTORY OF AN ARCHEOLOGICAL PRESERVE

Robert H. Lister and Florence C. Lister

Division of History
Southwest Cultural Resources Center
Southwest Region
National Park Service
Department of Interior

**SOUTHWEST CULTURAL RESOURCES CENTER
PROFESSIONAL PAPERS NO. 24**

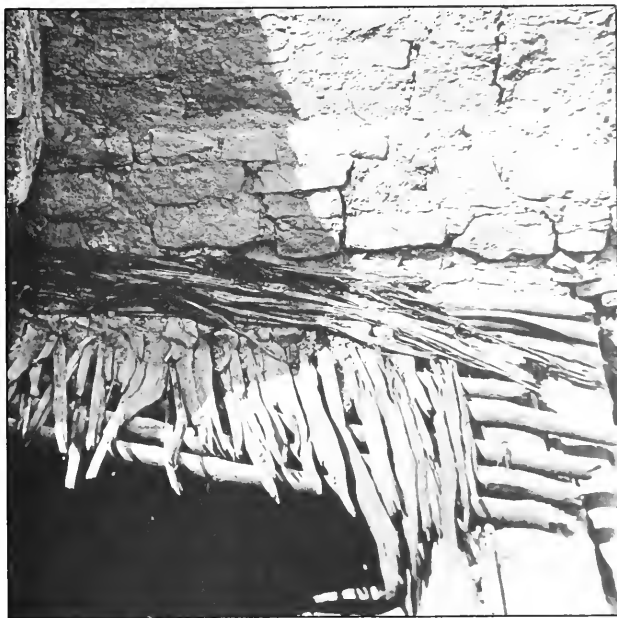
Figure 3.6. Exposed first-story roof of primary beams, cross poles, and strips of cedar bark.

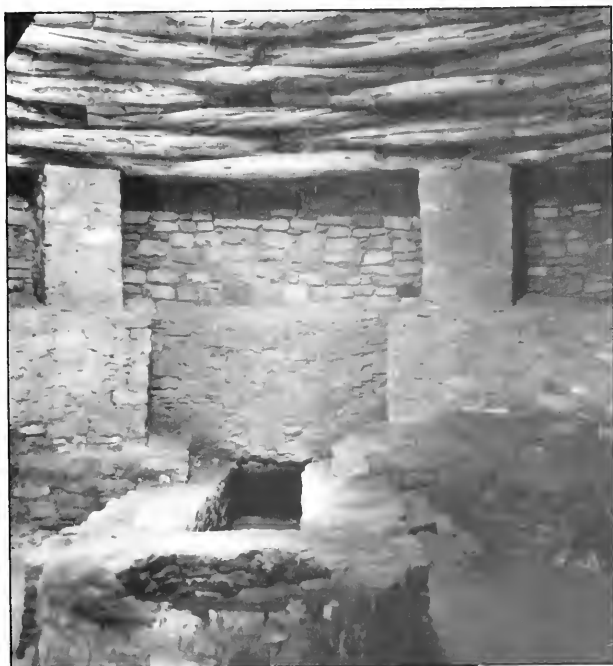
Figure 3.12. Interior of Kiva E, showing reconstructed cribbed-log roof.

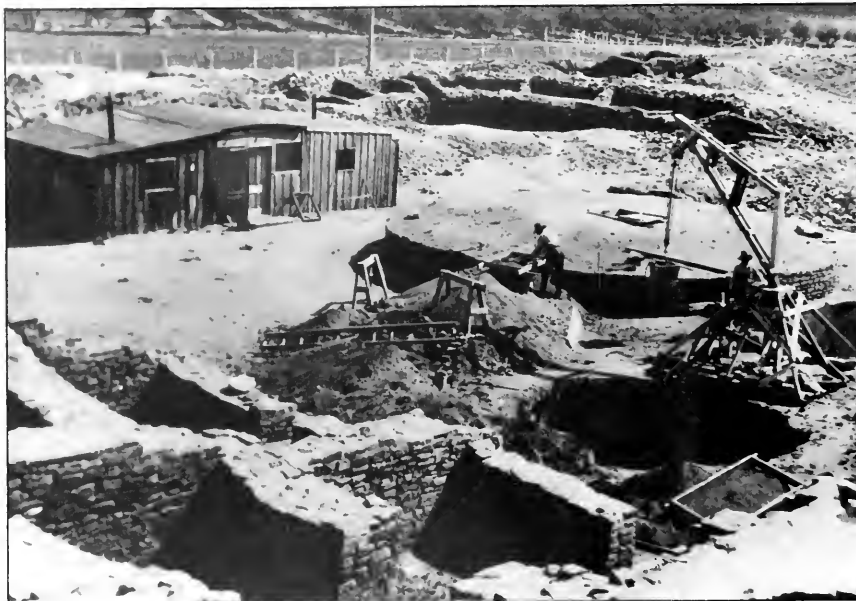
Figure 3.13. Overview of the West Ruin in 1918 showing roofed Kiva E, Kiva I being cleared with hoist and bucket, storage shed, and capped walls.

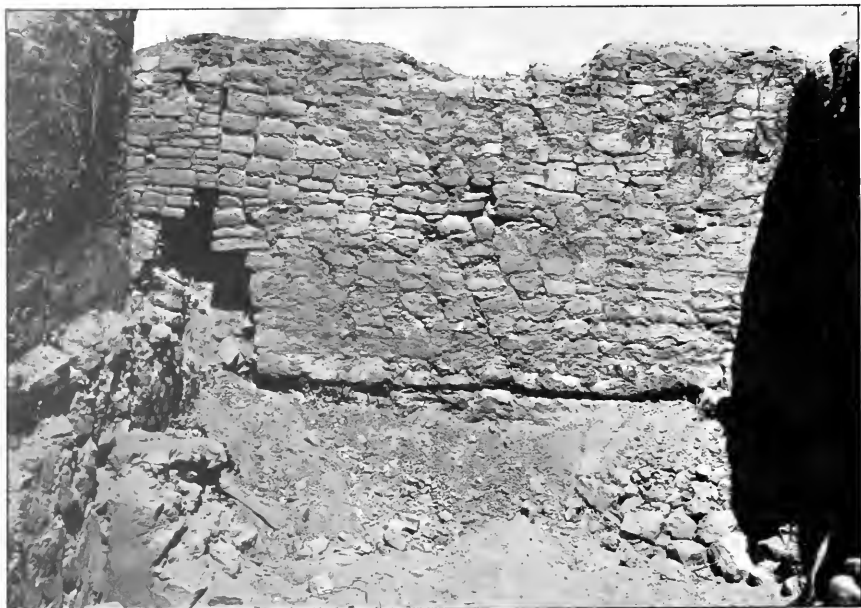
Figure 3.14. Mesa Verde-style wall built on top of Chaco debris in unidentified West Ruin room. (Courtesy American Museum of Natural History).

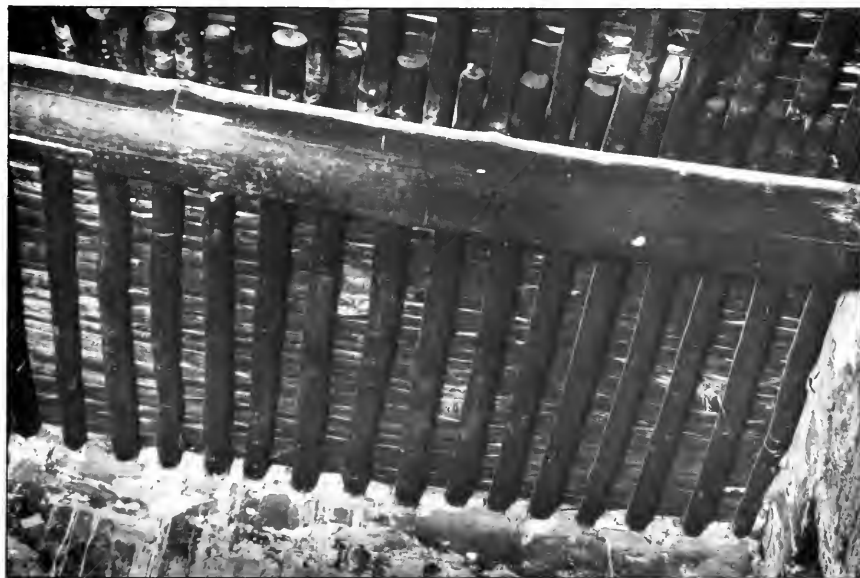
Figure 3.21. Intact aboriginal ceiling in the West Ruin as seen from the floor.

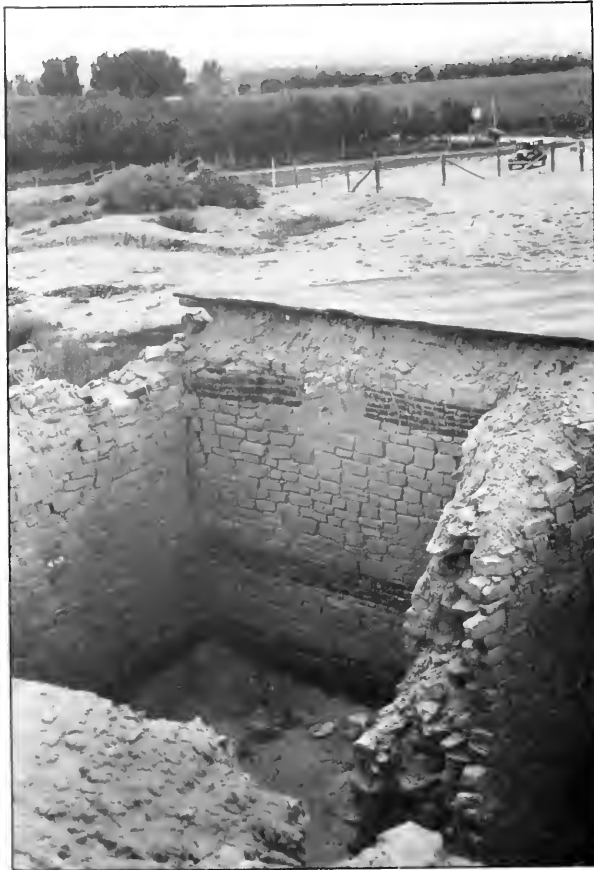
Figure 3.22. Room in southwest corner of the West Ruin showing bands of green stone inset within more typical sandstone masonry. Modern tar paper roof at center right covered a utility room during the 1920s. Mound at upper left was an aboriginal refuse dump.

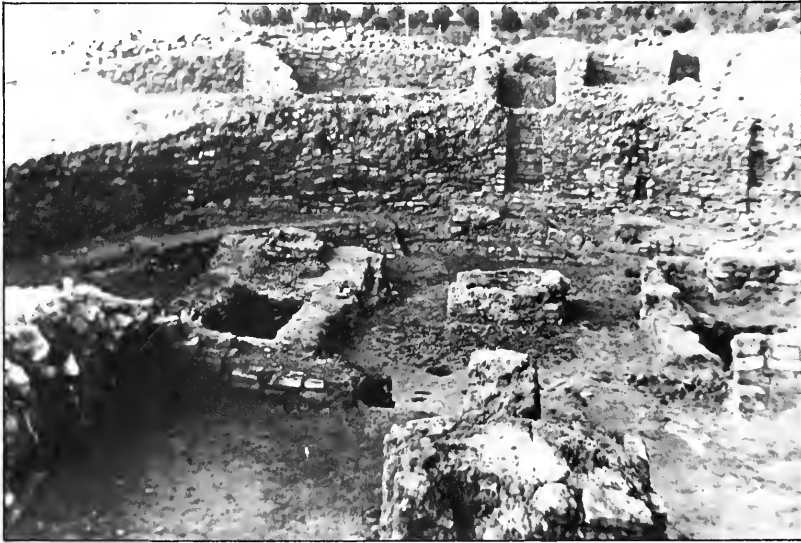
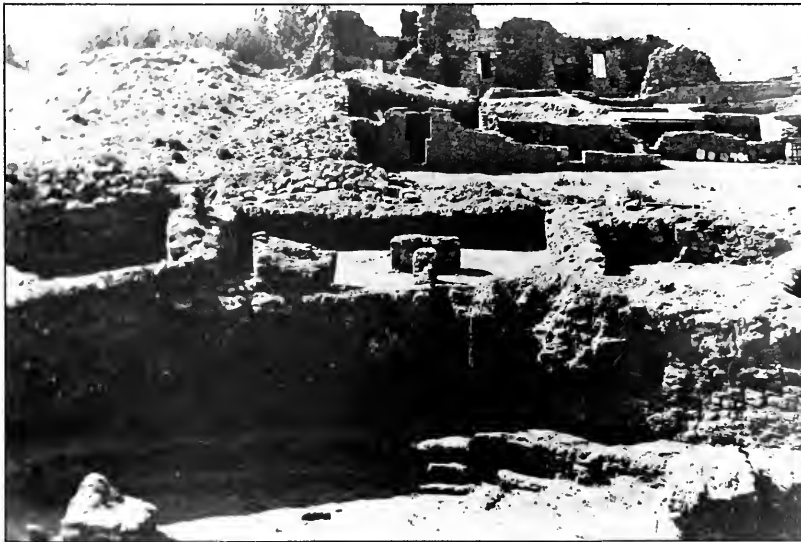
Figure 3.24. Excavated Great Kiva in 1921, showing floor features.
Above, view to south; below, view to north.

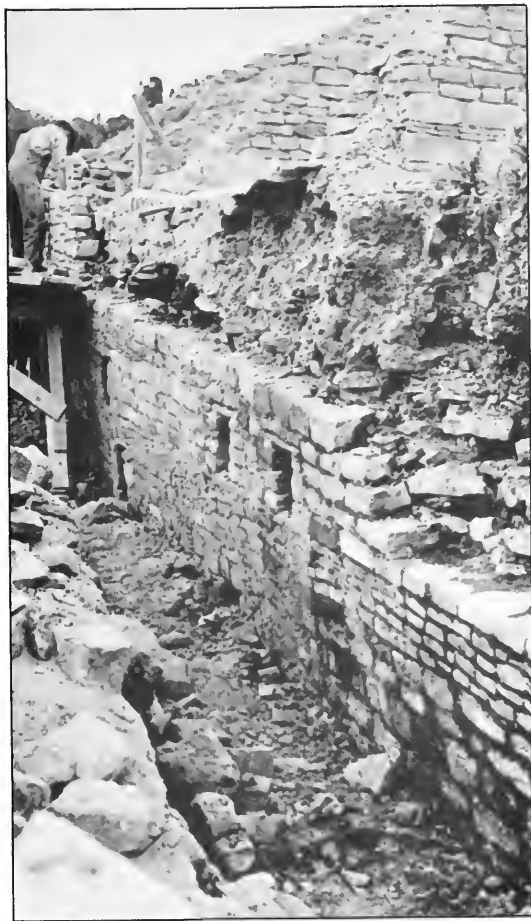
Figure 7.7. Resetting exterior wall of North Wing, 1934. Rubble core and shaped sandstone veneer evident.

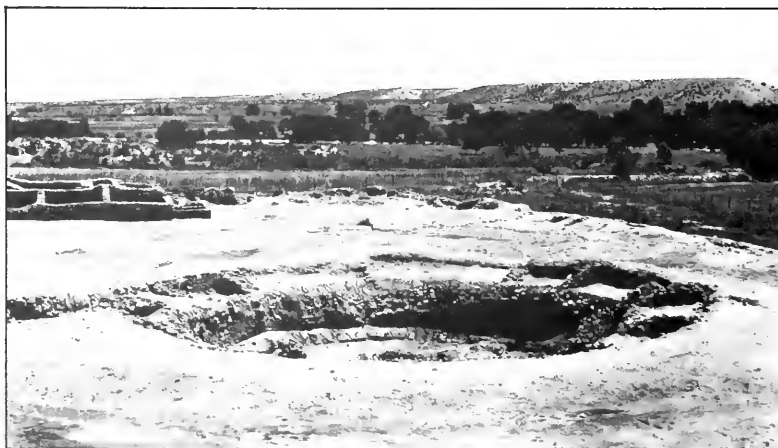
Figure 7.9. Deteriorated condition of Great Kiva prior to reconstruction in 1934.

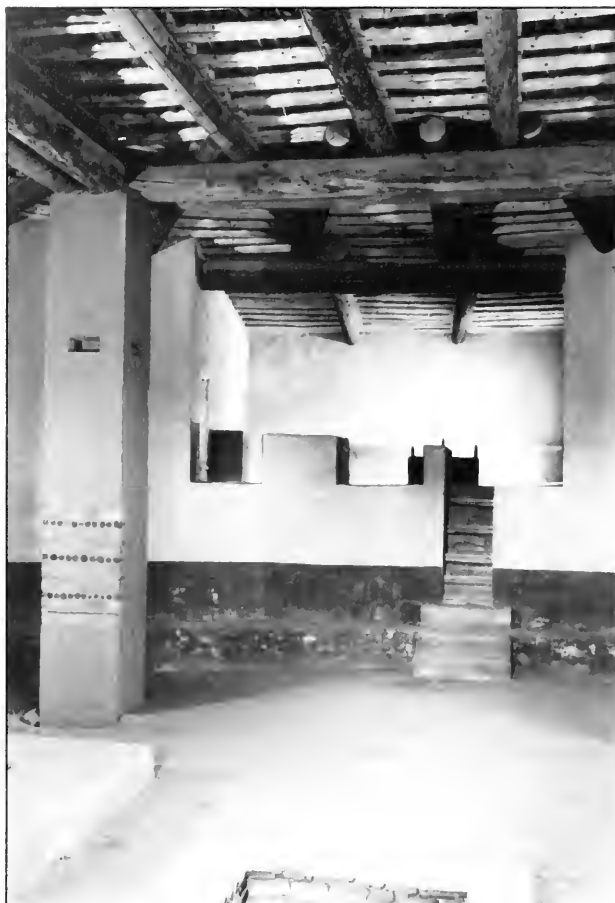
Figure 7.11. Interior of restored Great Kiva, looking toward north altar room. Crossbedded poles in roof support column left exposed to demonstrate method of construction.

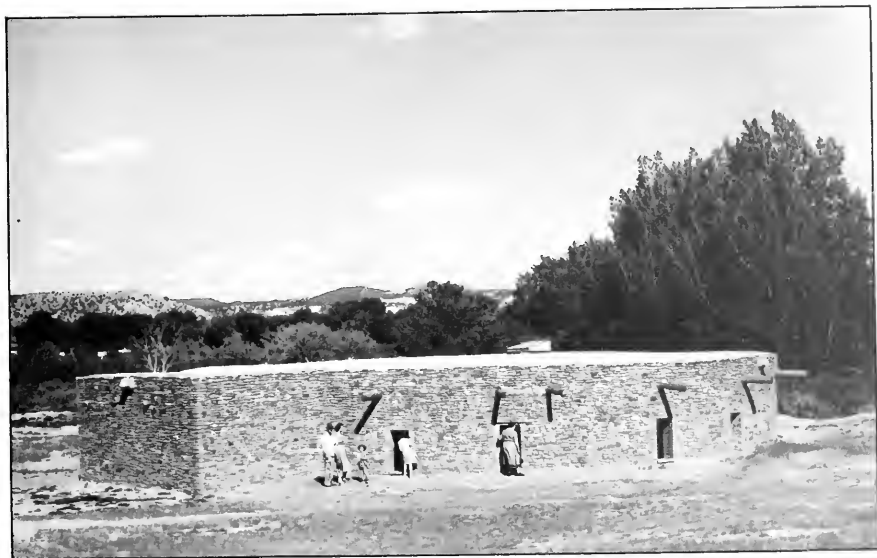
Figure 7.12. Reconstructed Great Kiva, northwest side. Doorways open into encircling surface rooms.

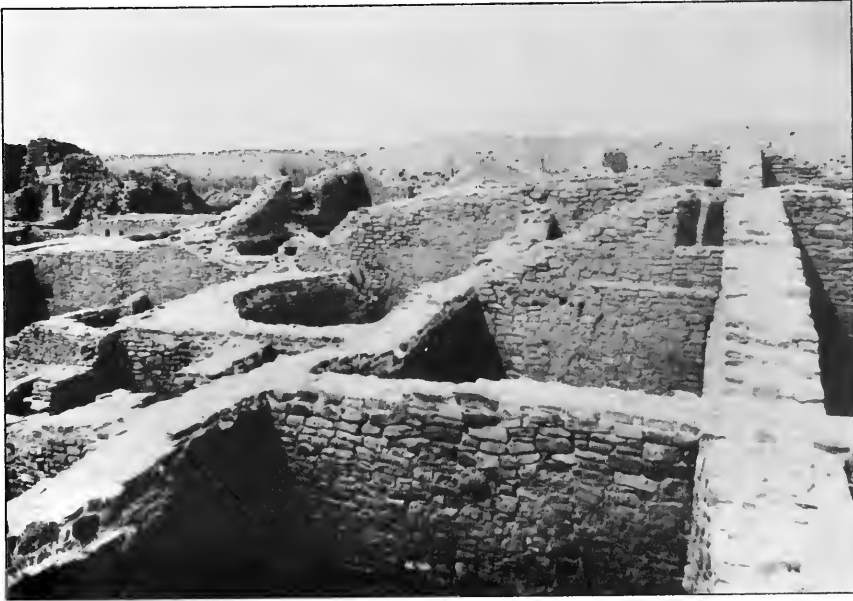
Figure 12.1. View over northeast corner of West Ruin showing cement wall capping.

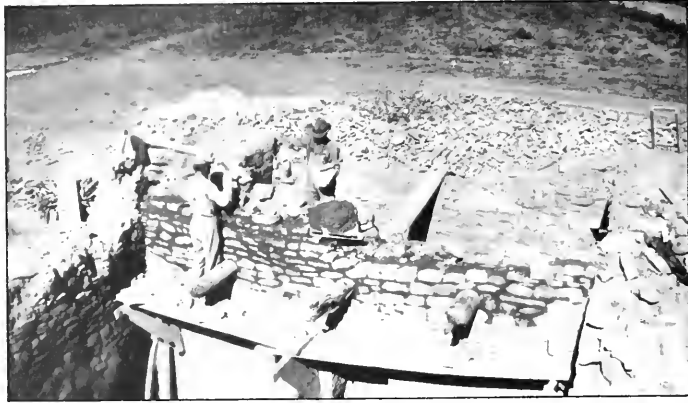
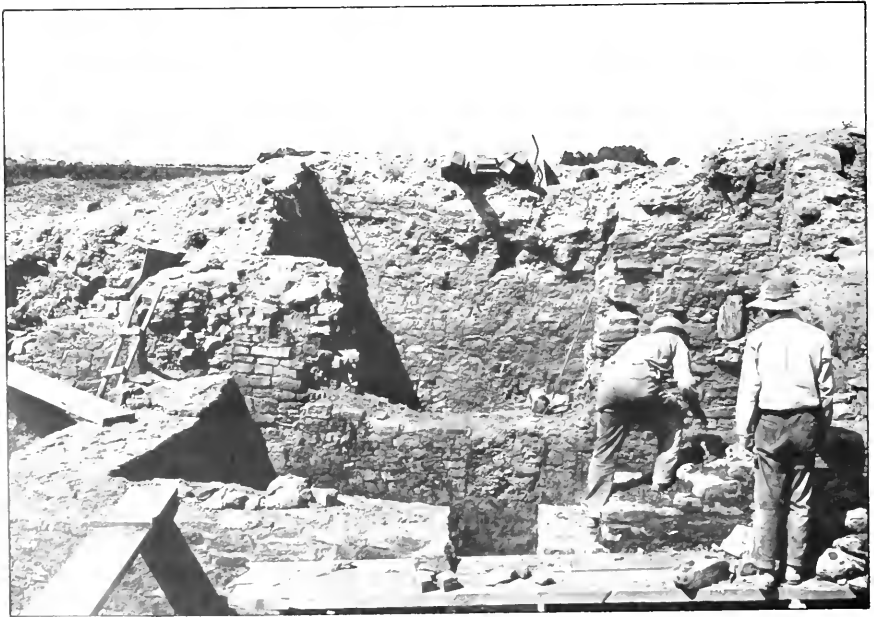
Figure 12.2. Two views of wall repairs, West Ruin, by American Museum of Natural History crews.

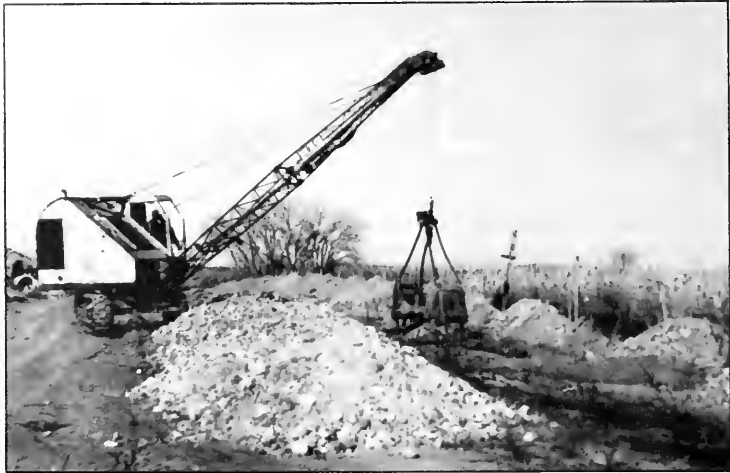
Figure 12.5. Dragline digging deep north drainage trench, 1946.

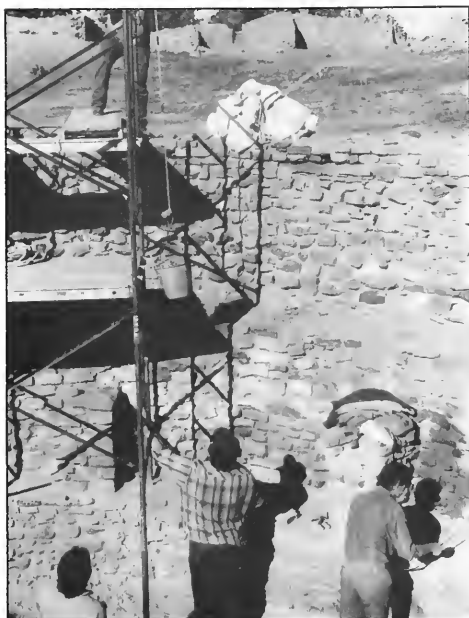
Figure 12.8. Routine maintenance stabilization at Aztec Ruins being done in connection with regional training exercises, May 1989.

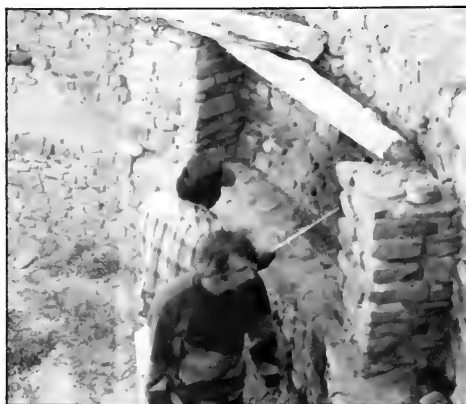
Figure 12.9. Routine maintenance stabilization at Aztec Ruins being done in connection with regional training exercises, May 1989.
